Manhole Inspection Summary

Manhole # S03CC2014MH

Insp Date: **10/3/06 11:12 AM**

Location Address: **6111 WESTERN RUN DR**

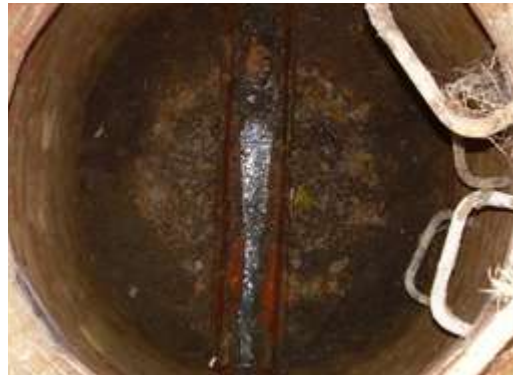
Top View

Corbel infiltration. Evidence of surcharge - Bench debris.

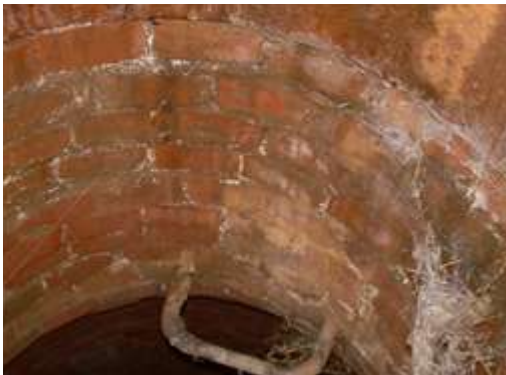
Defect

Frame leaks. Adjustment infiltration.

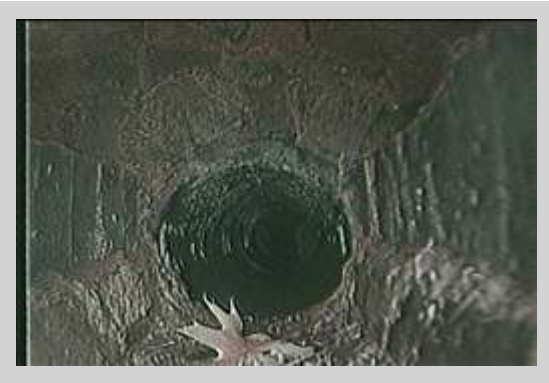
8 in. Circular Gravity Sewer Pipe Out @ 12 O'Clock

Comments **The O12 pipe picture shows grease deposits inside of the pipe.**

Deposits: ☐ None ☐ Mud ☐ Sludge ☐ Debris ☒ **Grease**

Silt Depth: **0** (in.) Deposits Extent: **Light**

Infiltration: **Evidence** Pipe Seal Cond: **Unknown**

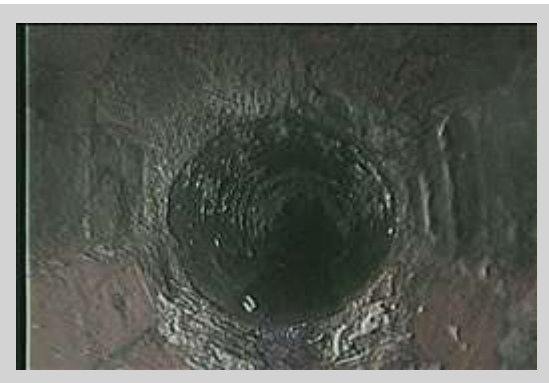
8 in. Circular Gravity Sewer Pipe In @ 6 O'Clock

Deposits: ☐ None ☐ Mud ☐ Sludge ☐ Debris ☒ **Grease**

Silt Depth: **0** (in.) Deposits Extent: **Light**
